# Transformation of a Ferry in a COVID-19 Ship Hospital: Crew Occupational Safety and Health Issues According to the Experience of Liguria Public Health Port Authority <sup>†</sup>

**Abstract:** In March 2020, a ferry (Splendid G.N.V. Company, Italy) moored in the port of Genova (Northwest of Italy) was transformed into a medical care facility for COVID-19. The project intended to help infected patients that required low-intensity care, were discharged from hospitals in the Liguria Region and were not yet able to return home. The aim was to share some of the treatment burden of the completely overcrowded local ashore hospitals and to free up bed spaces for patients in the acute phase of the disease. In this work we highlighted under the health port authority perspective the safety issues that the crew faced resulting from the exceptional and very unusual allocation of ashore medical facilities on a passenger ship.

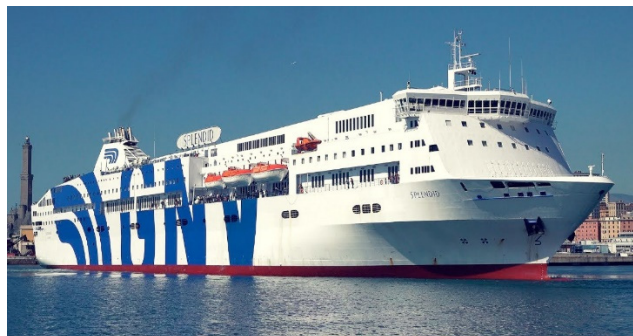
**Figure 1.** The GNV Splendid.

The GNV Splendid (IMO number 9015747) is a long-distance ro-ro ferry (gross tonnage of 39,139 tons, 214 m length), fitted with 567 guest cabins in total (Figure 1).

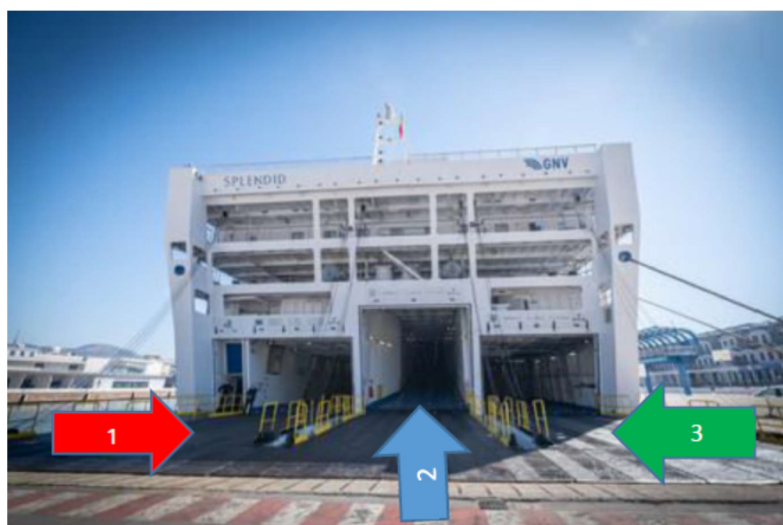
Issues	Actions
Access to the ferry	Pre-triage of patient ashore. Identification of three separated access pathways (see Figure 2). One RED right-side stern gangway further divided into (a) water side: healthcare staff and clean materials; (b) internal side: patient ambulances and dirty material. Two BLUE central gangway: ship and pantry supplies. Three GREEN left-side stern gangway: crew and external staff for technical interventions.
Air handling and ventilation	Equipment to avoid short circuits between safe and unsafe areas. Air treatment units separated for vertical zones. Additional extraction system from the patient cabins to create negative pressure.
Management of waste and bed linen	All waste from deck 7 was considered hazardous medical waste. Before leaving the hospital area, the waste containers were decontaminated externally with a chlorine solution. Dirty bed linen was placed in double bags (inner biodegradable). Waste and dirty bed linen were removed by specialized companies.

**Figure 2.** Pathways access. 1 external side: health staff, clean material. Internal side: patient ambulances and dirty material 2 ship and pantry supplies 3 crew and external staff for technical interventions.

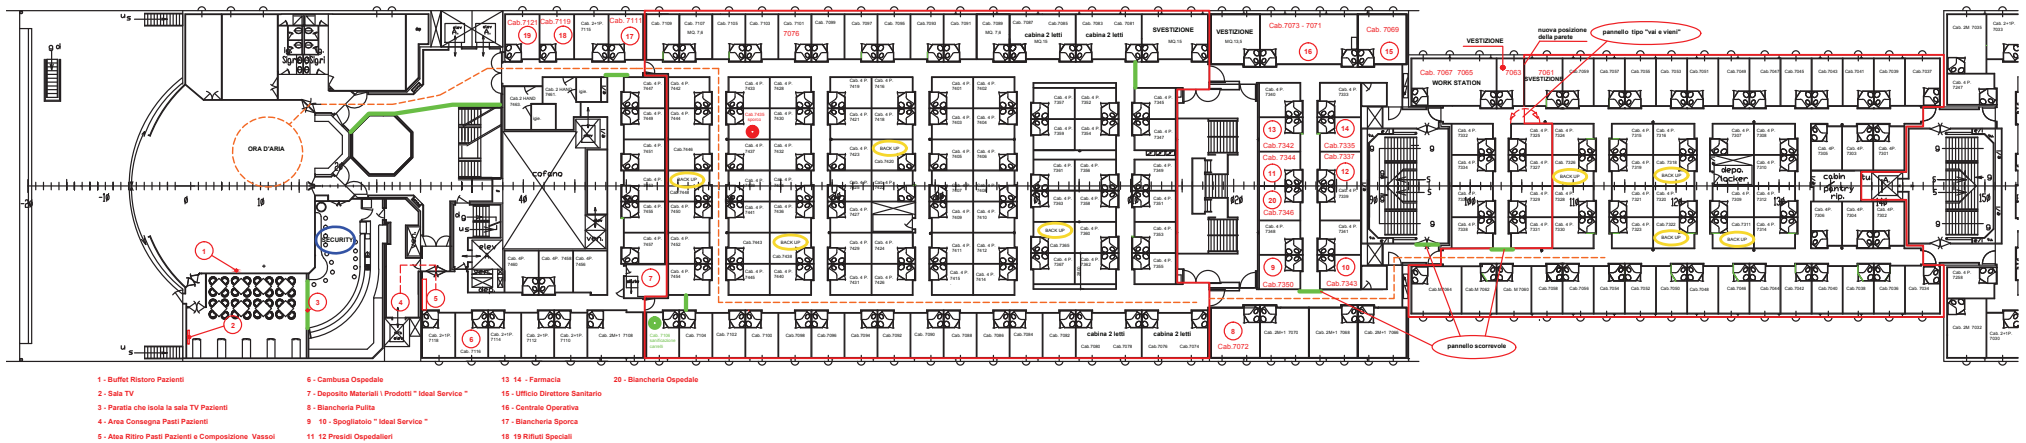
## Appendix A. Plan of Deck 7—Hospital Area

The area for hospitalization, located on deck 7, consisted of a first module of 27 cabins (23 single and 4 double beds for patients with particular needs (e.g., same family unit, etc.)), followed by a second module consisting of 25 cabins (all single beds), adjacent to the previous one. A common area—the catering zone and fresh air zone—was also set up on the outdoor deck. A plan is reported in Appendix A.

**MIN SPLENDID - 7 ATLANTIC DECK**
